Title:	Newmarket Farm Excavation Project Design
Author:	David Cuthbertson
Job title	Project Manager
Address	Flat 3, 12 Grafton Street Brighton East Sussex BN2 1AQ
Email:	scienceinthegreen@yahoo.co.uk
Mobile:	07905279986
Derivation:	Conversations with former tenants, extensive historical research, followed by meetings with Malcolm Emery (English Nature's E. Sussex Senior Reserves Manager), Greg Chuter (Assistant County Archaeologist), John Funnell (Brighton & Hove Archaeological Society), Emma O'Connor (Barbican House Museum), and others. Based on the <i>Newmarket Farm Dig Proposal</i> document, MoRPHE and ESCC guidelines.
Origination Date:	January 23rd, 2013
Date of last revision:	March 26, 2013
Version:	1.0
Status:	Consultation Draft
Circulation (alphabetical order):	Greg Chuter; Peggy Cuthbertson, Co-researcher for desk-based historical research; Malcolm Emery; John Funnell; Louise Parkinson, Reserves Manager, N.E.; Susan Simpson, Adviser with responsibility for the SSSI/SAC, N.E.; Smiths Gore, Brighton & Hove City Council's Farmland Agents.

1 Project Name

Newmarket Farm Dig.

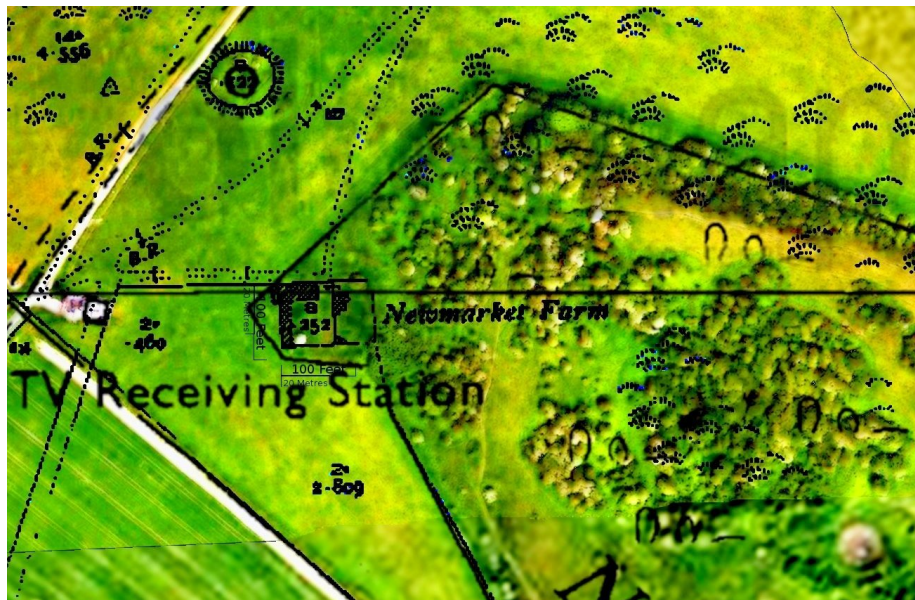
Figure 1: Newmarket Farm site, drawn using Google satellite imagery, overlaid by old and new OS mapping.

The 0.1 Ha Newmarket Farm site is located just inside the NW boundary of Castle Hill National Nature Reserve, just below the summit of Newmarket Hill,

about 100 m to the SE of the television aerial; centred on grid reference TQ 36355 06992 (to an accuracy of +/-2 m). It is located in the Parish of Kingston near Lewes. The land is owned by Brighton & Hove City Council, who have delegated responsibility for their farmland portfolio to Smiths Gore. It is managed by Natural England and the surrounding land is farmed by B&HCC tenant, Mr Martin Carr of Balsdean Farm.

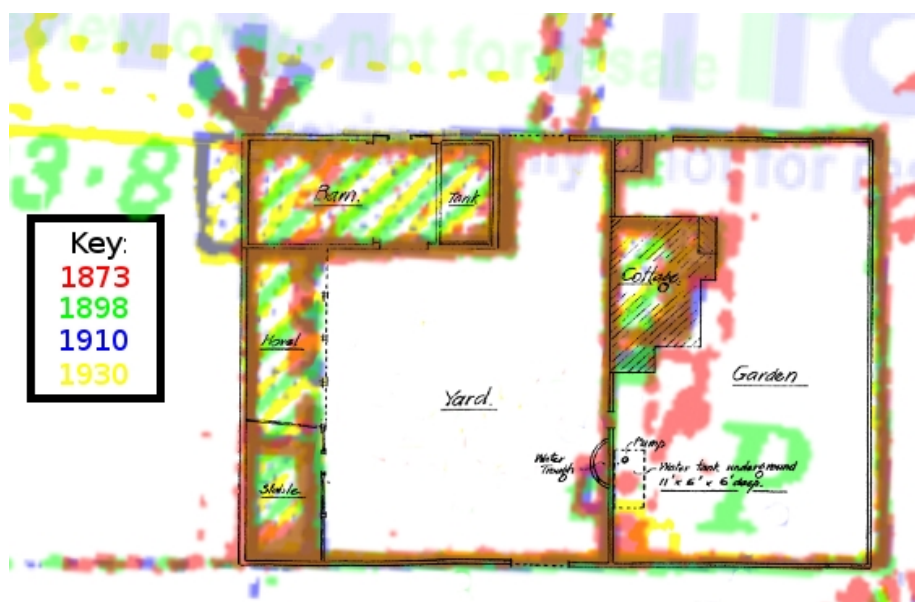
Figure 3: Newmarket Farm from OS maps and a 1921(?) plan.

Old O.S. maps, and a plan found in papers dated 1921, show a number of structures and alterations. The letter ‘P’ represents a pump to the rear of the house. A sale document from 1911 described the farm as “*comprising Cottage (containing three bedrooms, &c.), Barn (one bay of which is fitted for use as a water tank), open Cattle Lodge, Stable, Hay Room and lean-to Wagon Lodge*”. The plan drawn on behalf of Oscar Selbach, who bought the farm in 1921, shows an underground water tank, about 6’ x 6’ x 11’, to the south of the house, though it does not include the barn extension built sometime before 1910.

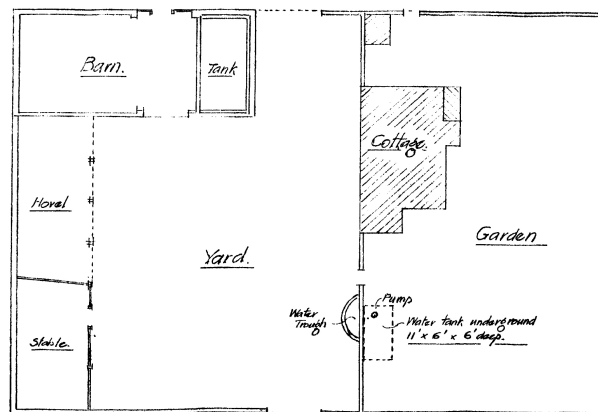
Plan of Buildings at Newmarket Farm Kingston.
for O. C. Selbach Esq.

Figure 5: Newmarket Farm plan drawn for Selbach in 1921.

(though other memories place it next to the house). There are three memories of a *well* (relatively shallow - a ladder's depth, possibly between 3 and 6m?) adjacent to the house, outside a window to the north, or on the E side of the house, or under a window to the south of the house! There is no memory of a pump — just a bucket on a rope. The *front door* is remembered as being to the right of centre of the N gable end and, at this time, opened on to the *kitchen*. Cooking was done on a *paraffin stove*. There was a *copper* for heating water for the laundry. The *stairs* to the *bedrooms* faced the front door(?) to the right of the kitchen. Under the stairs may have been a *small pantry*. Beyond was a door into the *parlour* on the S end of the house. Here was the only *open fire*, which was (probably) only lit on special occasions, when *coal* was normally used as fuel. The *bedrooms* upstairs, were accessed via two doors, a third bedroom being accessed via a door in the bedroom at the front (N end) of the house. There were no *windows* on the E side of the house. On the E side of the front gable was a (probable) *woodshed*. All doors closed using a *latch* (including the front door).

The farmyard was (probably) cobbled. To the right of the stable(s) in the SW corner of the farmyard was a harness store. Correspondence dating to 1941 between the farmer down in Balsdean and Brighton Corporation indicates there was an area suitable for the housing of pigs in the Newmarket Farmyard with a concrete floor to prevent their effluent contaminating the groundwater. Also in the farmyard, against the farmyard/garden wall, to the S of the house was a water-trough for the stock. Between 1934 and 1938 the farmyard was hardly used other than as a store for equipment that was not being used. At this time all ploughing was with horses but, from 1938 they were replaced by tractors.

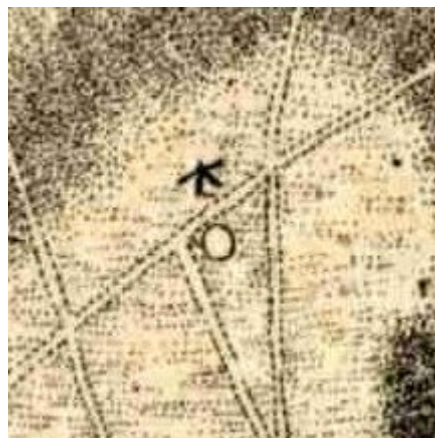
Figure 7: Newmarket Hill, Yeakel & Gardener’s late 18th c. map.

as shown on a late 18th century map by Yeakel and Gardener. This map showed a symbol of unknown significance, about a hundred metres to the north of the Newmarket Farm site. It resembled a mill with half its sails missing. Speculation leads the author to consider the possibility of a gibbet for the hanging of smugglers. Alternatively it may have been a signal post in times of war.
